State of California & The Resources Agency  
DEPARTMENT OF PARKS AND RECREATION  
**LINEAR FEATURE RECORD**

Resource Name or #: (Assigned by recorder) Y-9

**L1. Historic and/or Common Name:** Hungry Hollow Canal

## **Appendix F: Cultural, Paleontological, and Historical Resources**

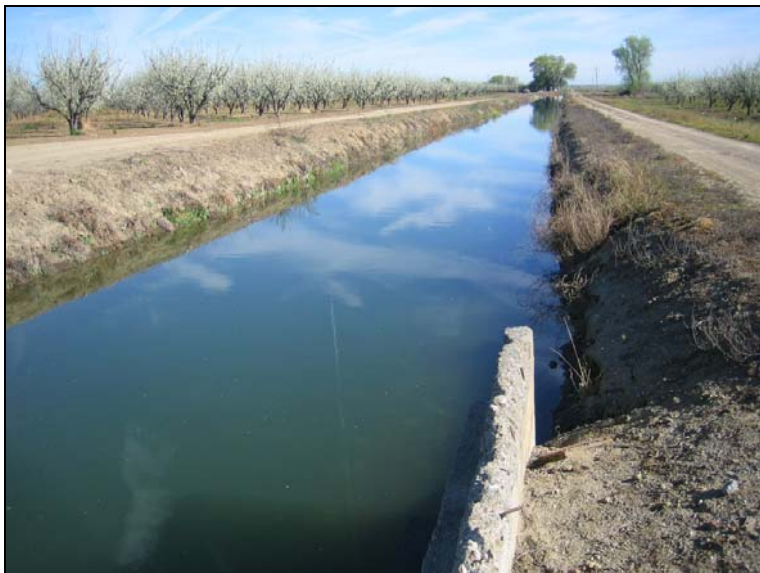
**L8a. Photograph, Map or Drawing**

The Hungry Hollow Canal was only recorded for 1300 feet. It is a long earthen-walled canal presently in use that measures approximately 25 feet wide and 9 feet deep. The irrigation water in this canal originates from Cache Creek and passes through the Capay Dam and the West Adams Canal before spurring to the Hungry Hollow Canal.

**L7. Integrity Considerations:** The canal is in good condition, in use, and actively maintained.

Northeastern overview of Hungry Hollow Canal; 03/19/2007; IMG\_1365

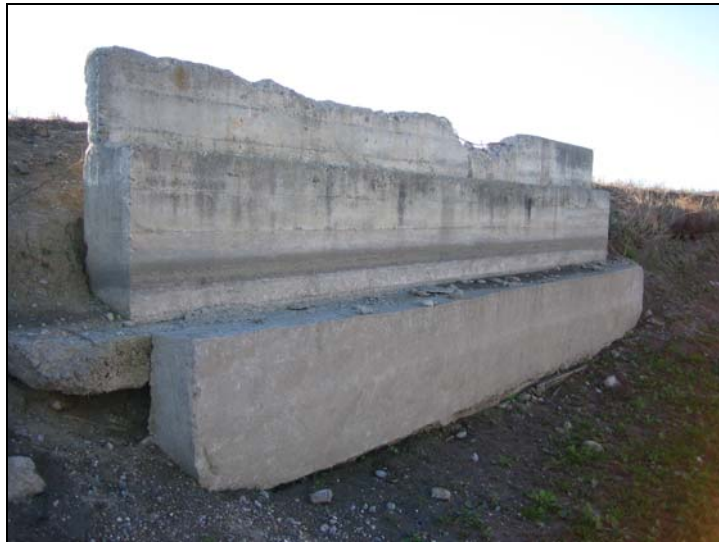
Feature Y-9a: This feature consists of the remnants of a bridge that once crossed the Hungry Hollow Canal. Its concrete foundations are situated on either side of the earthen canal. Only the stepped (likely for the beams of the bridge) foundations of the bridge are in existence. The date of manufacture for this bridge is unknown, but it is likely from the historic era. The bridge once connected to dirt access roads on either side of the canal. The bridge would have spanned approx. 25 feet. The height of the foundations or abutments from the canal ground level is approx. 5 feet 10 inches. The eastern bridge abutment measures approx. 20.5 feet long, 34 inches thick at the present water level, and 14 inches thick above the water level. The ledge for the beams is approx. 18 inches wide. The bridge is in poor condition; rusted metal rebar is exposed in broken portions of the foundations.

Southeastern overview of the eastern bridge abutment of Feature Y-9a; 02/23/2007; IMG\_003

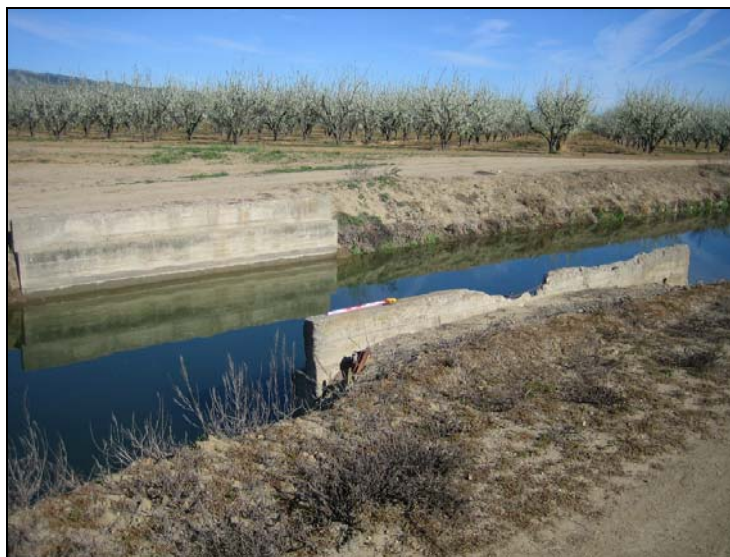
Northwestern overview of Feature Y-9a; 03/19/2007; IMG\_1363.

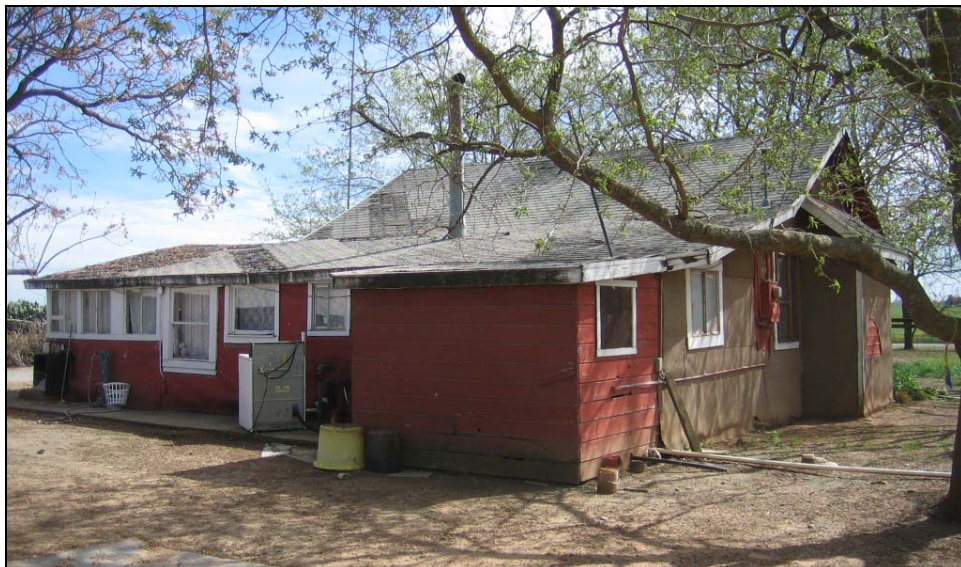
Overview of the north and west elevations of Building No.1; 03/19/2007; IMG\_1381

Building No. 1 is approximately 84 feet from the north edge of CR 17, and measures approximately 39 feet long x 36.5 feet wide. The main block of the building is one-and-one-half stories high and has a pier-and-post foundation. The roof is sheathed with composition roofing and the exterior walls are clad with horizontal clapboard siding, wrapped in several places with tar paper. A tall metal stovepipe extends from the slope of the roof of the one-story addition at the north side of the main block. The current entrance is at the east end of the addition. It features a six-paneled door flanked by a pair of 9-paned windows on the south side and two wood-framed single paned fixed windows on the north side. The east facing, gable end of the main block depicts an aluminum slider at each end. (See continuation sheet for more description of this building)

The north elevation of Building No. 1 features a ribbon of three aluminum sliders at the east end, a larger wood-framed double-hung window in the center, and three additional odd sized windows at the west end. A small shed-roofed addition extends north from the west end of the length-wide addition; it features a door at the east end and a single screened window at the center of the west elevation. A small shed-roofed addition, about the size of a closet, is centered under the gable of the west elevation. Two aluminum sliders are on each side of the small addition and a third, smaller aluminum slider is on the one-story addition at the north end. It appears that the original façade is on the south side, although the wooden six-panel door does not appear to be used for entry. Two aluminum slider windows, similar in size to those on the east elevation are at each side of the door; a large air conditioning unit is seated on a wood-frame and attached to the window at the east end. The main block of the building has the appearance of a mail order house of balloon-frame construction popular in the late nineteenth to early twentieth century. However, the building has been modified through a rambling progression of later additions and shed attachments. (See continuation sheet for barn description)

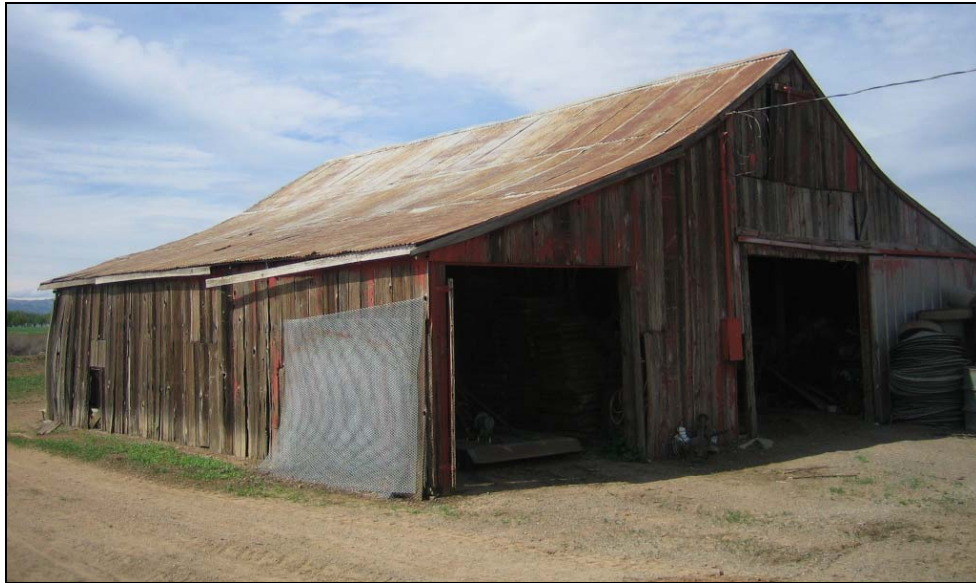
Northwest of the farm residence is a large historic barn (Building No. 2) measuring 72 feet long x 38.5 feet wide. Numerous bunk houses and storage buildings are nearby the barn. It is front-gabled and the roof is sheathed with corrugated iron panels; it exhibits flared ends. The barn lacks a foundation and there is evidence of termite damage. The walls are clad with vertical wood planks, generally about 9 inches wide. The age of the historic building has not been determined, but during the inventory, it was noted that only round-headed nails were used during construction of this building.

The only fenestration on the south elevation is a rectangular cut-out on the lower portion of the wall which appears at the west end. The fascia is loose along the east end of the roofline and the west end of the elevation is unstable. It appears to be buckling from items piled against the wall inside the building.

Building No.2: Northwestern overview of east façade and south elevation of the barn at Y-20; 03/19/2007; IMG\_1384.

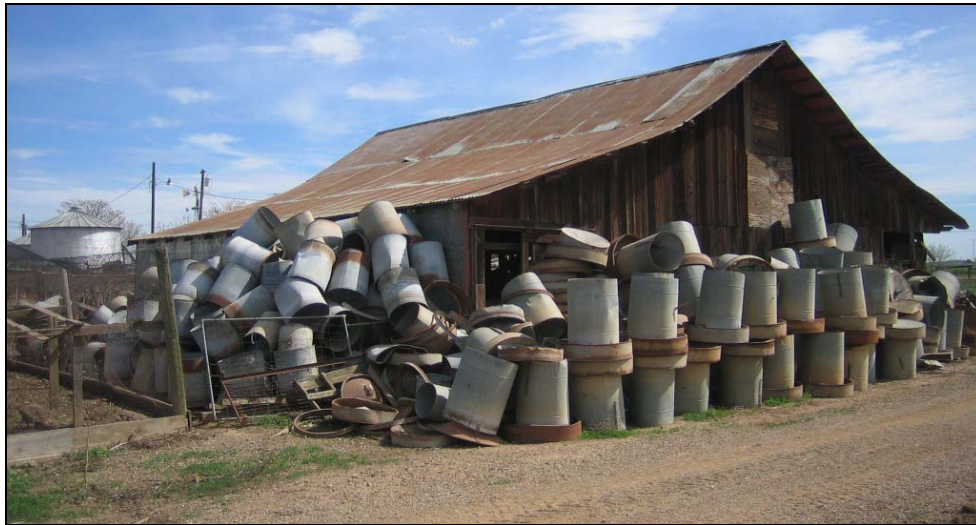
The barn is presently being used for storing hay and agricultural equipment; however, it abuts a large pheasant cage. As a result, there are poultry feeders are piled high and strewn about next to the building's north and west elevations. The south end of the west elevation features two doorways at the south end that are now unstable. Two more adjacent doorways are present on the north end. Centered under the gable is a large linear piece of sheet metal used to repair the wall. Throughout the building additional maintenance repairs have been made with metal sheets and plywood. It is in fair to poor condition.

Building No.2: Southeastern overview of the north and west elevations of the barn at Y-20; 03/19/2007; IMG\_1388.

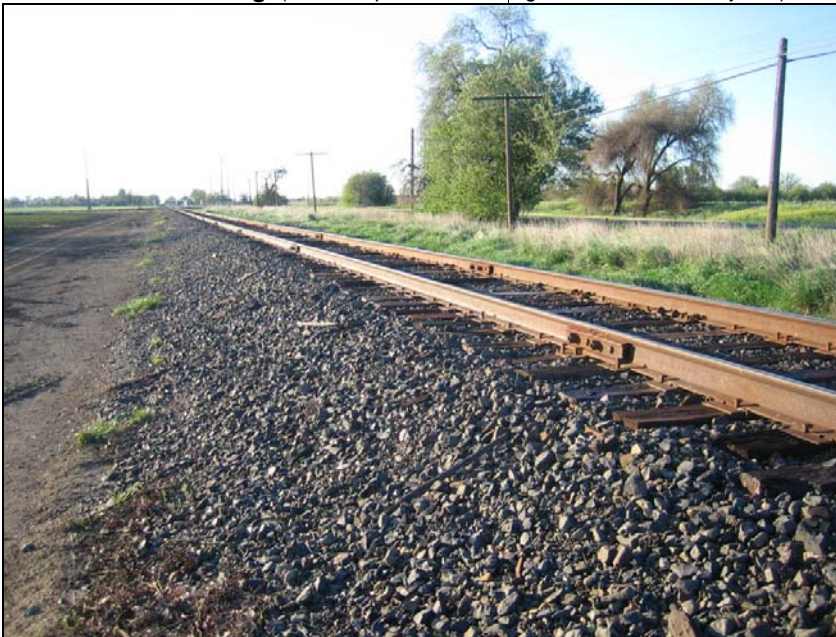
Overview of the Southern Pacific Railroad tracks, facing southwest; 03/21/2007; Camera Pictures 001.

Railway Company railroad grade has been replaced on the same alignment by modern tracks. The railroad is presently used by Southern Pacific and actively maintained.

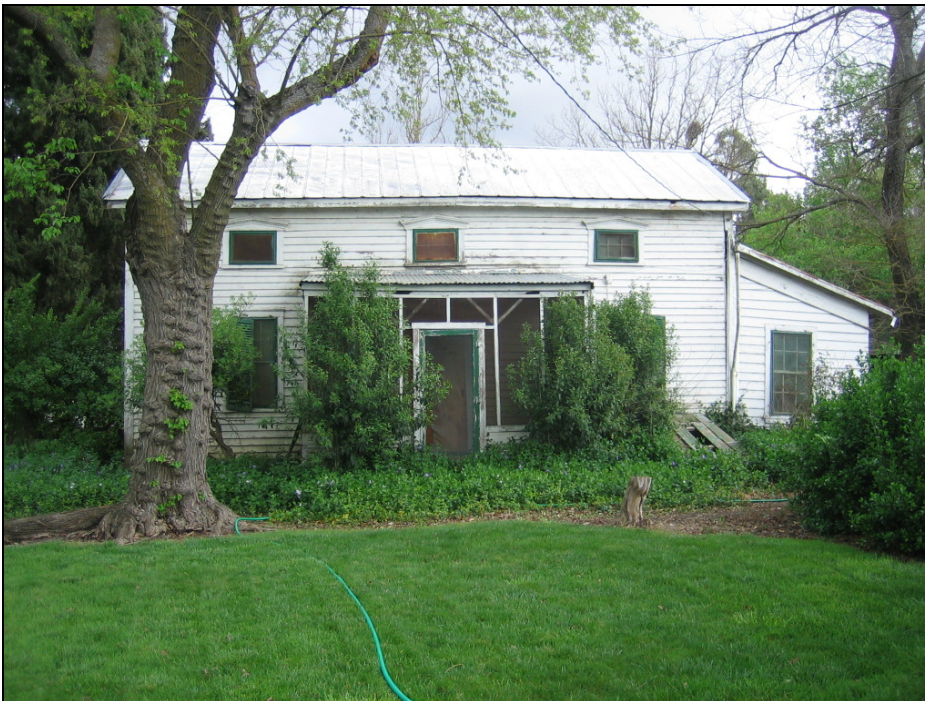
**Building No.1:** This building consists of the main residence. It is unoccupied and in fair condition. The house is white with green trimming around the door and windows; it has a tin roof. The covered porch area has a corrugated iron roof. It has an estimated construction date of 1860.

**P5b. Description of Photo:**  
Front western façade of Building No.1; 03/20/2007; IMG\_1411.

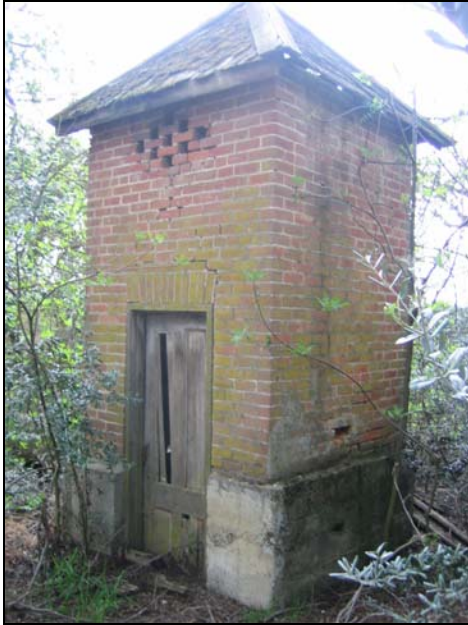
**Building No. 2:** This building consists of a brick smokehouse. It is in fair condition and has a roof made of wood shingles. Concrete was poured over the bricks at the base of the building for reinforcement.

Northern façade and eastern elevation of  
Building No.2, the brick smoke house;  
03/20/2007; IMG\_1422

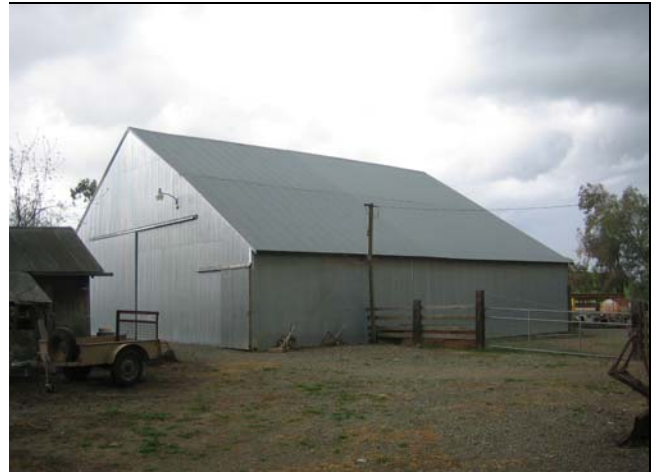
Southwestern overview of the northern and western  
elevations of the barn (Building No.3); 03/20/2007;  
IMG\_1424

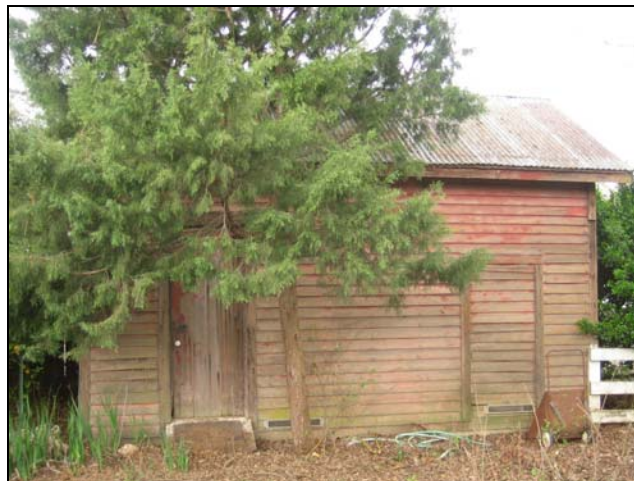
**Buildings No. 4 and 5:** These buildings consist of two historic bunkhouses. They are similar in construction and have red plank siding, a corrugated metal roof, and evidence of square nails.

Eastern façade of Building No.4, one of the two bunk  
houses that has square nails; 03/20/2007; IMG\_1426

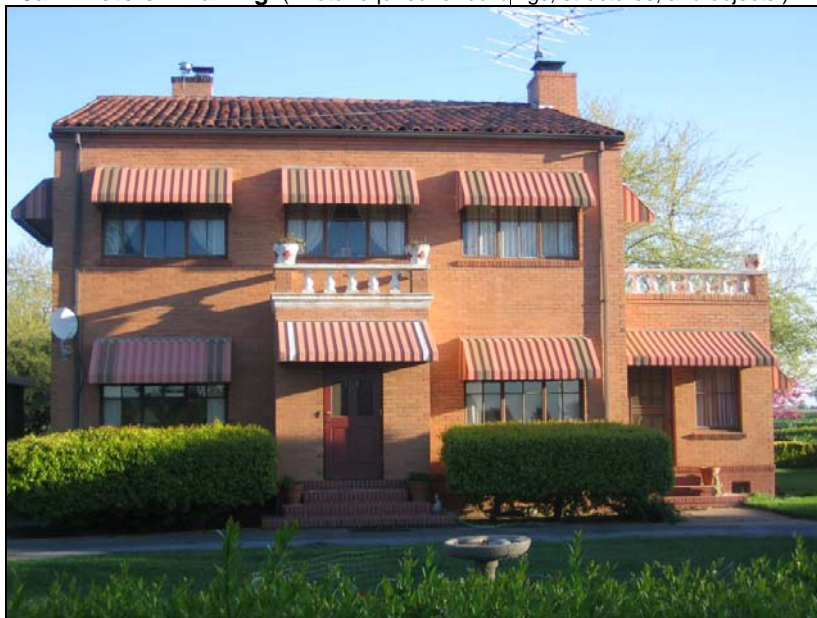
**Building No. 1:** Built in 1927, this residence is constructed of brick, and measures approximately 43 feet by 42 feet. The Mediterranean Revival-style house appears to have two floors and a basement. It has a ceramic tile roof and a brick foundation. The house also has two chimneys. The garden is well groomed and consists of a lawn with a bird bath, trimmed hedges and a grape vine fence, fruit trees, and a cork oak tree (*see Continuation Sheet, page 2*).

Northern overview of the southern façade of residence (Building No.1); 03/21/2007; CP003.

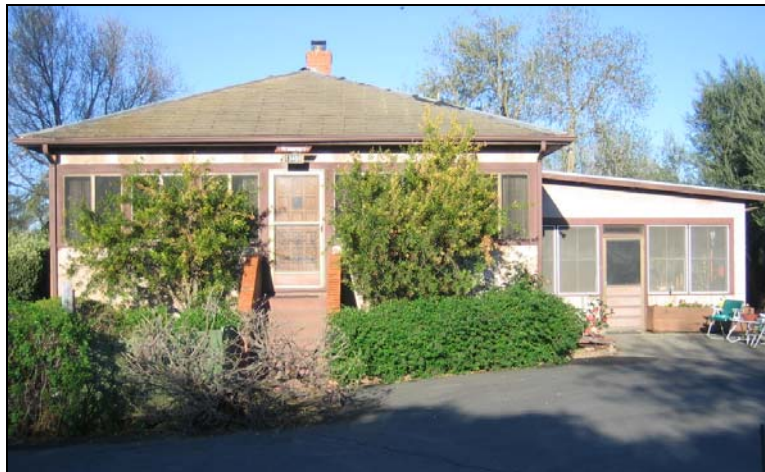
**Building No. 2:** This other older single-storied residence was, according to the owner, built between 1865 and 1875. The house still has its original foundations. The home was remodeled in 1949 and was originally two stories; it measures approximately 50 feet by 28 feet. The house has asbestos siding, one chimney, and a modern tar shingle roof. The house is surrounded by trees with a garden constructed of brick that has star-, clover-, circle- and square-shaped designs made of upside down beige stoneware bottles (circa. 1870).

Eastern façade of Building No.2, the older residence at HRI-4/114; 03/21/2007; CP018.

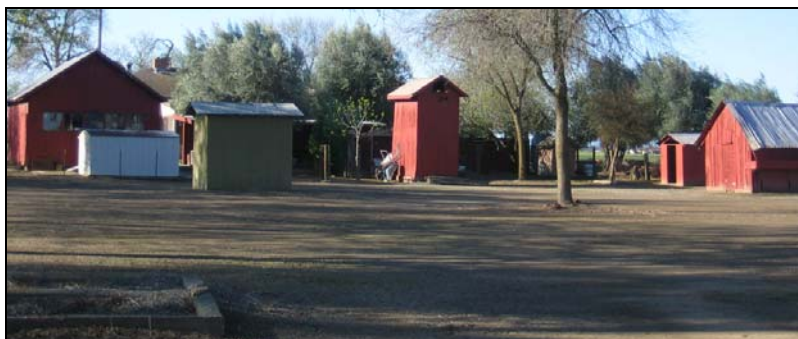
**Building No. 3:** This resource is a garage built in the early 1900s. It has red painted wood siding, a sheet metal roof, track doors, and a cement foundation. The garage measures approximately 32 feet by 18.5 feet.

Southerly overview, from east to west, of three red historic buildings: the garage, the smoke house, and the bird house of HRI-4/114; 03/21/2007; CP032.

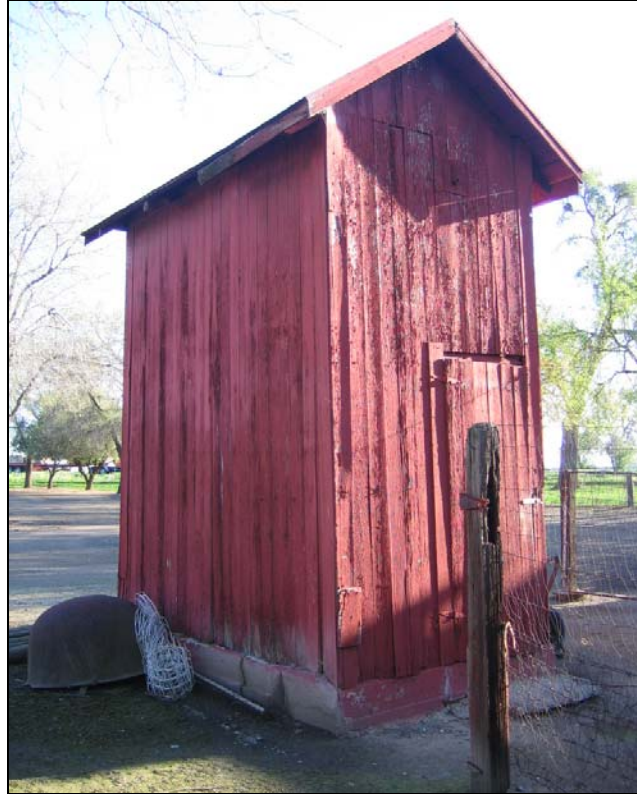
**Building No. 4:** This resource is a smoke house built in the 1880s. It is approximately 15 feet high with red painted vertical side boards and a roof consisting of tar paper shingles, and measures approximately 10 feet 8 inches by 6.5 feet. It also has a 1 foot high concrete slab foundation on top of an older brick footing. The floor is poured concrete. There is evidence of square nails on the building.

Northeasterly overview of the western elevation and southern façade of the smoke house (Building No. 4) at HRI-4/114; 03/21/2007; CP024.

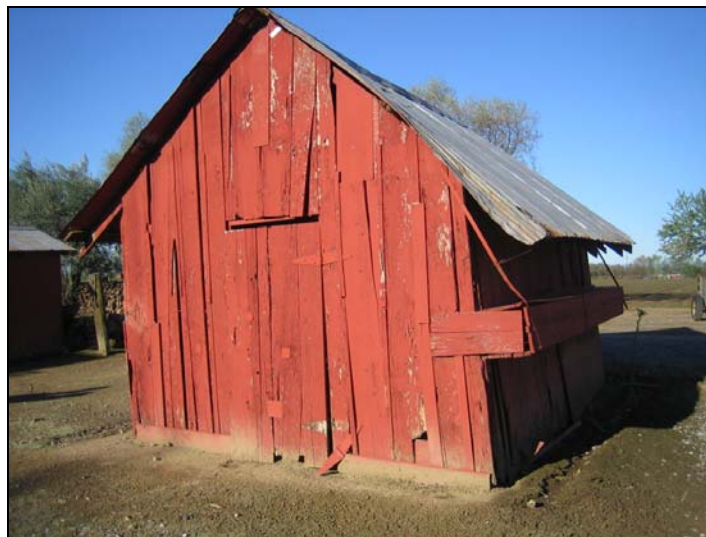
**Building No. 5:** This resource is a bird house with a red painted wood siding and a corrugated iron roof. It has no visible foundation, but does have square nails; it measures approximately 15 feet by 10 feet 8 inches.

Southwesterly overview of the eastern façade and northern elevation of the bird house (Building No. 4) at HRI-4/114; 03/21/2007; CP026.

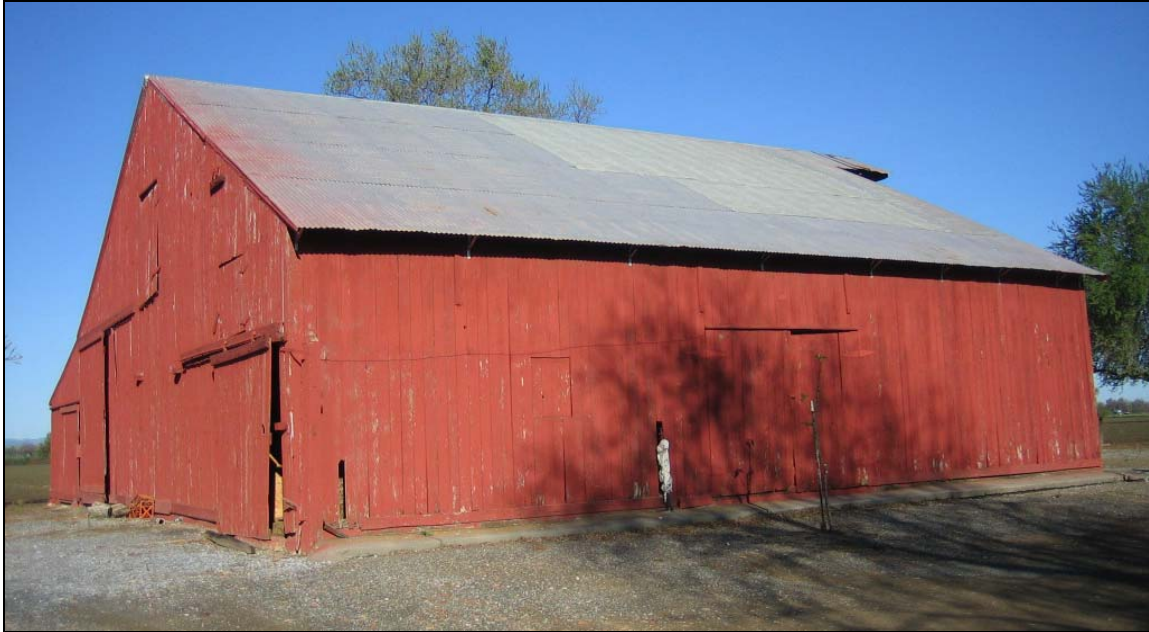
Northwestern overview of the southern façade and eastern elevation of the barn (Building No. 6) at HRI4/114; 03/21/2007; CP028.

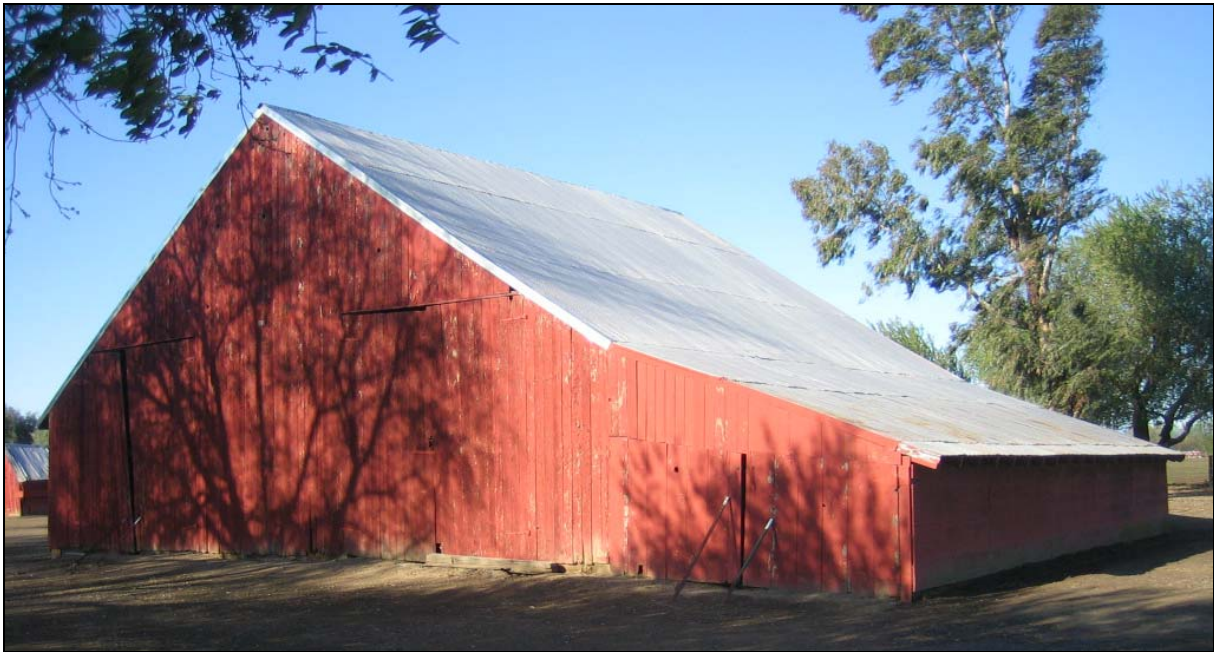
**Building No. 7:** This resource is a large wooden granary. It is sided with red painted wooden planking and appears to be approximately 25 feet high, and measures approximately 59 feet by 41 feet. The roof is relatively new and consists of unpainted corrugated metal. The foundation is made of brick and is four bricks high. The wooden siding of the granary has evidence of square and modern nails. This building also has four large doors.

Southwesterly overview of eastern façade and northern elevation of the granary (Building No. 7) at HRI-4/114; 03/21/2007; CP030.

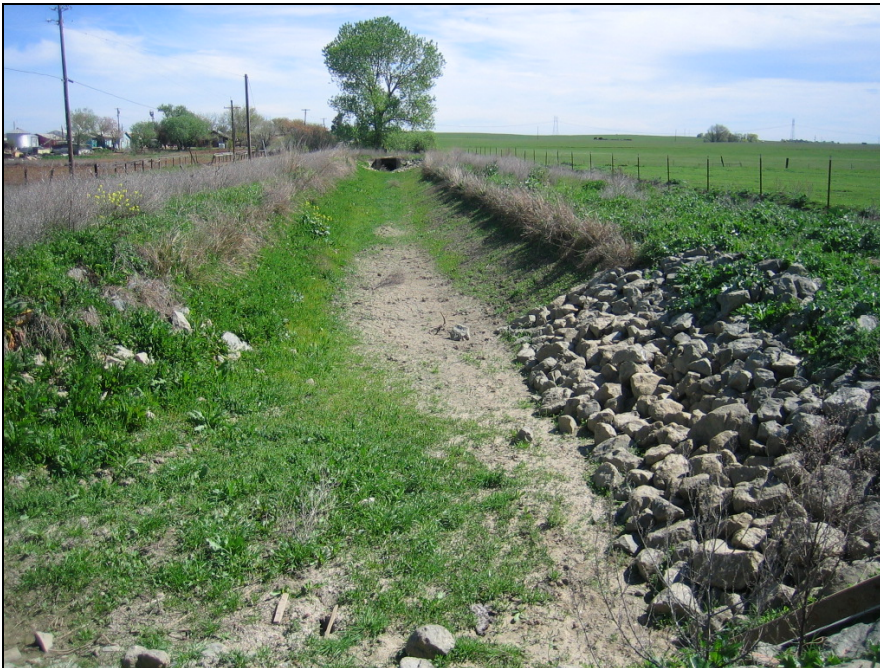
Eastern overview of Goodnow Slough; ditch is on the south side of County Road 17 and at this point parallel to CR 17; 03/19/2007; IMG\_1368.

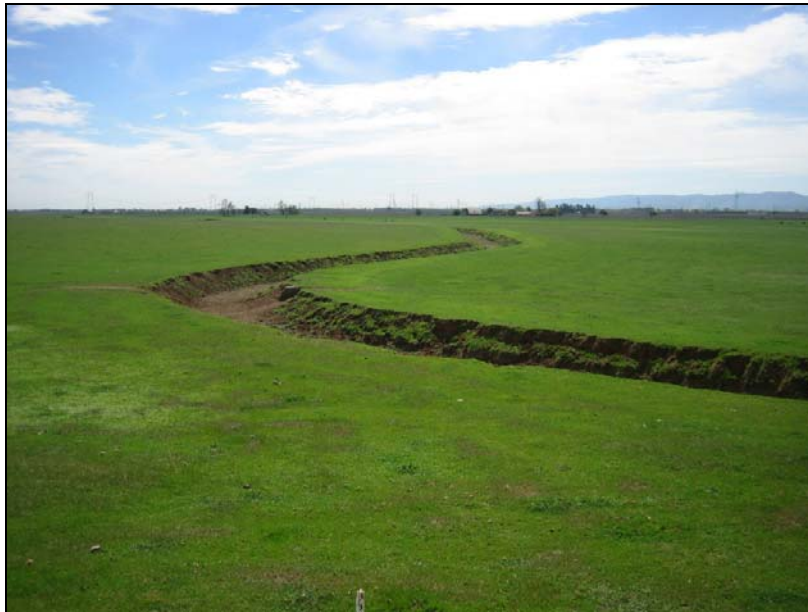
Southerly overview of Goodnow Slough situated in grazing lands south of County Road 17; 03/19/2007; IMG\_1369.

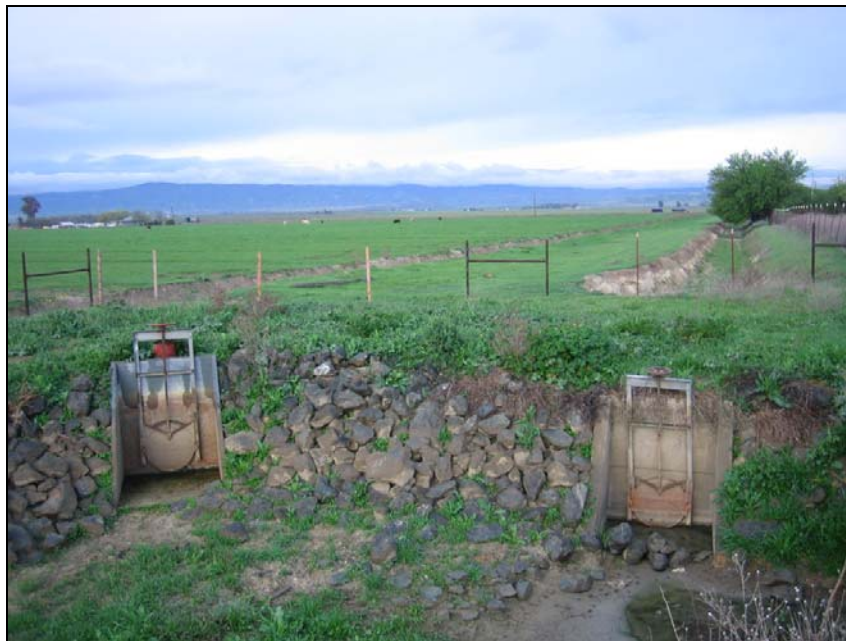
Southwestern overview of two ditch gates opening into two parallel spurs off the Goodnow Slough; 03/20/2007; IMG\_1389.

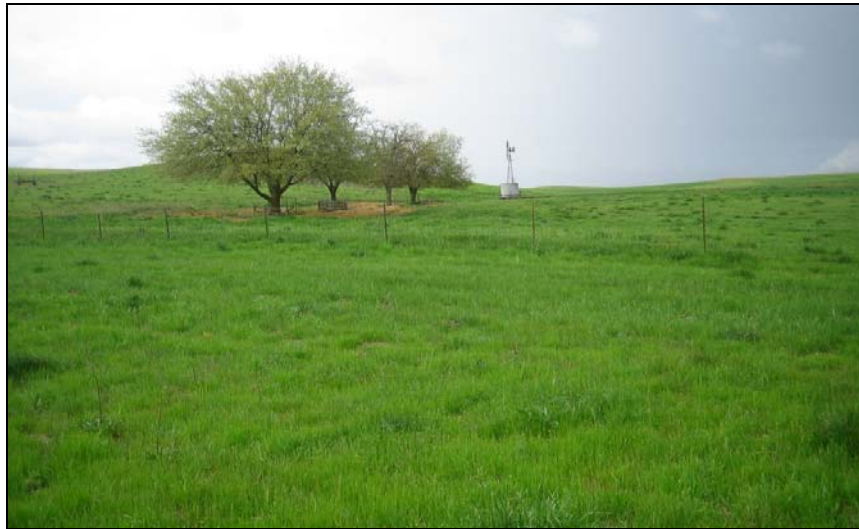
Southwesterly overview of water well with windmill, row of four trees, trough, and water tank, located 160 feet west of the Y-6 historic trash dump; 03/20/2007; IMG\_1393.

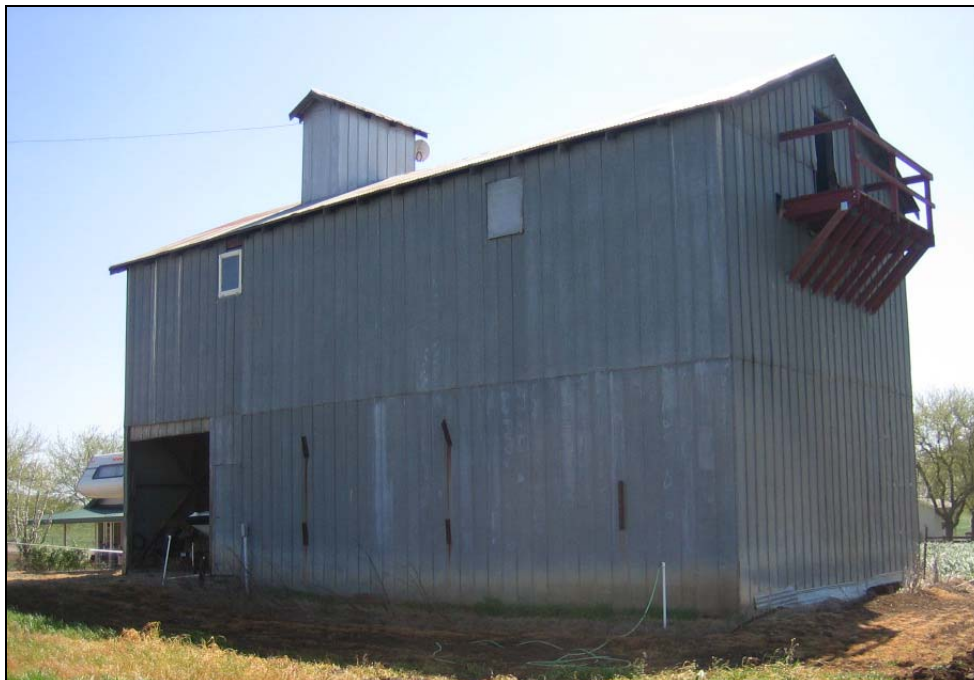
Granaries were commonly constructed with an upper grain storeroom and storage space below. The building was constructed with few windows to minimize invasions from rodents and other pests. However, the cupola was probably once vented using louvers to prevent spontaneous combustion, although it is also possible that there had been a door in the cupola to allow grain to be delivered into the building by an elevated conveyor. It is likely that the two pipes extending down on the east elevation were used for easy access to the grain for feeding livestock. Structurally, the former granary is in good condition; however, there have been modifications made to some of the windows, the cupola has been modified, and the balcony is a recent addition.

Southeastern overview of northern façade and western elevation of Building No.1, the granary at Y-7; 03/21/2007; IMG\_1467.

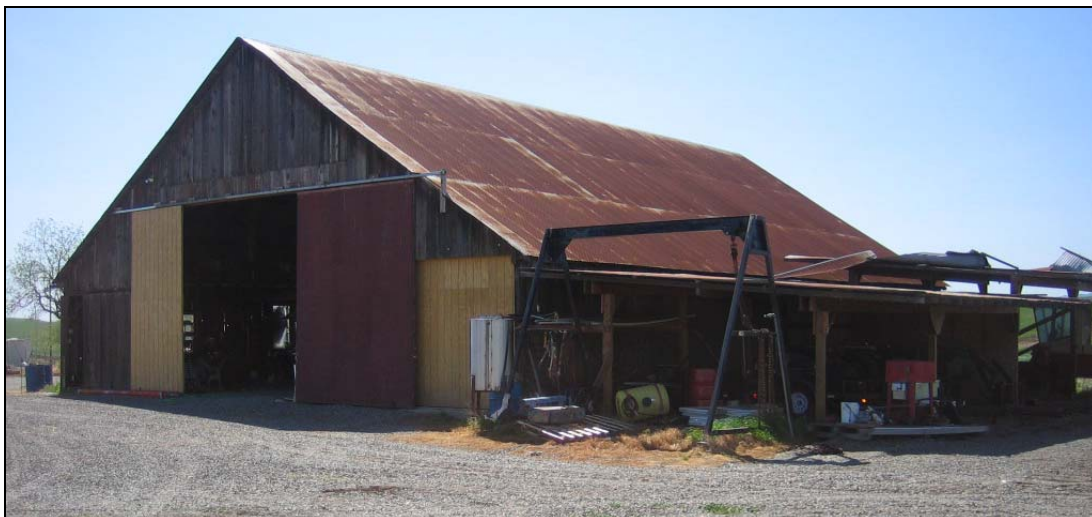
Farm Building #2 is northwest of Farm Building No. 1 and measures approximately 81 feet long x 56 feet wide, excluding the shed-roof projection on the north elevation. The barn was built in 1881 and appears to be the oldest building on the property. It exhibits two-stories and a wide expanse roofline. The moderate pitched front-gabled roof is sheathed with corrugated iron panels. The barn has a concrete foundation with a dirt floor, although concrete slabs cover sections of the floor. The timber-framed barn is sided with vertical wood planks on all, but the west elevation, and displays both cut nails and round-headed nails. Corrugated metal siding covers the west elevation. The east façade of the building features a large sliding wood-plank door in the center with an overhead track equipped with pulleys. New wood panels (or T-1-11 plywood) replace wood planks at either side of the door. The west elevation displays a smaller corrugated metal sliding door with an overhead track and pulleys on the west end. There is evidence that there was once a large door at the center of the elevation, similar to the one on the façade, but the door was later replaced by corrugated metal siding. The north elevation features a shed-roof extended roofline that is supported by wood posts. The extension is open-sided and miscellaneous equipment is stored under it. The only windows on the barn are on the south elevation. There are four aluminum-framed 1:1 pane windows spaced across the side of the building. The recently repaired barn is presently used for storing farming equipment, although it is likely that it was once used for livestock and/or hay storage. The replacement of wood plank cladding with corrugated metal panels and the addition of aluminium sliders on the south elevation have affected the integrity of the building.

Overview of east façade and north elevation of hay/horse barn at Y-7, facing southwest; 03/21/2007; IMG\_1473.

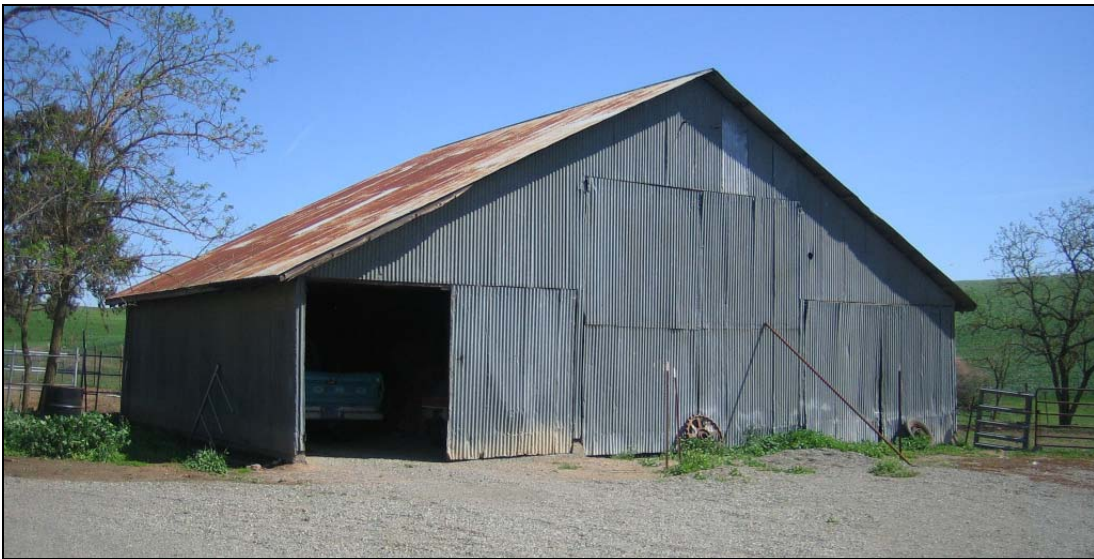
Overview of west façade and north elevation of the horse barn (Farm Building No. 3) at Y-7, facing southeast, 03/21/2007.
